Property Inspection Report

Sample Commercial Inspection, Ca 95123

I1028548

This is a well built and maintained recently renovated thirty-year old one-story church with an attached preschool.

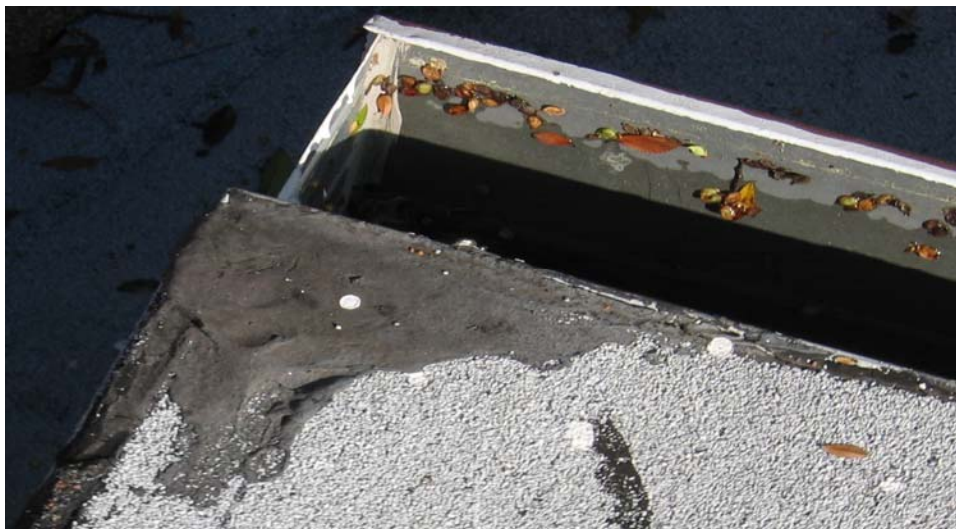
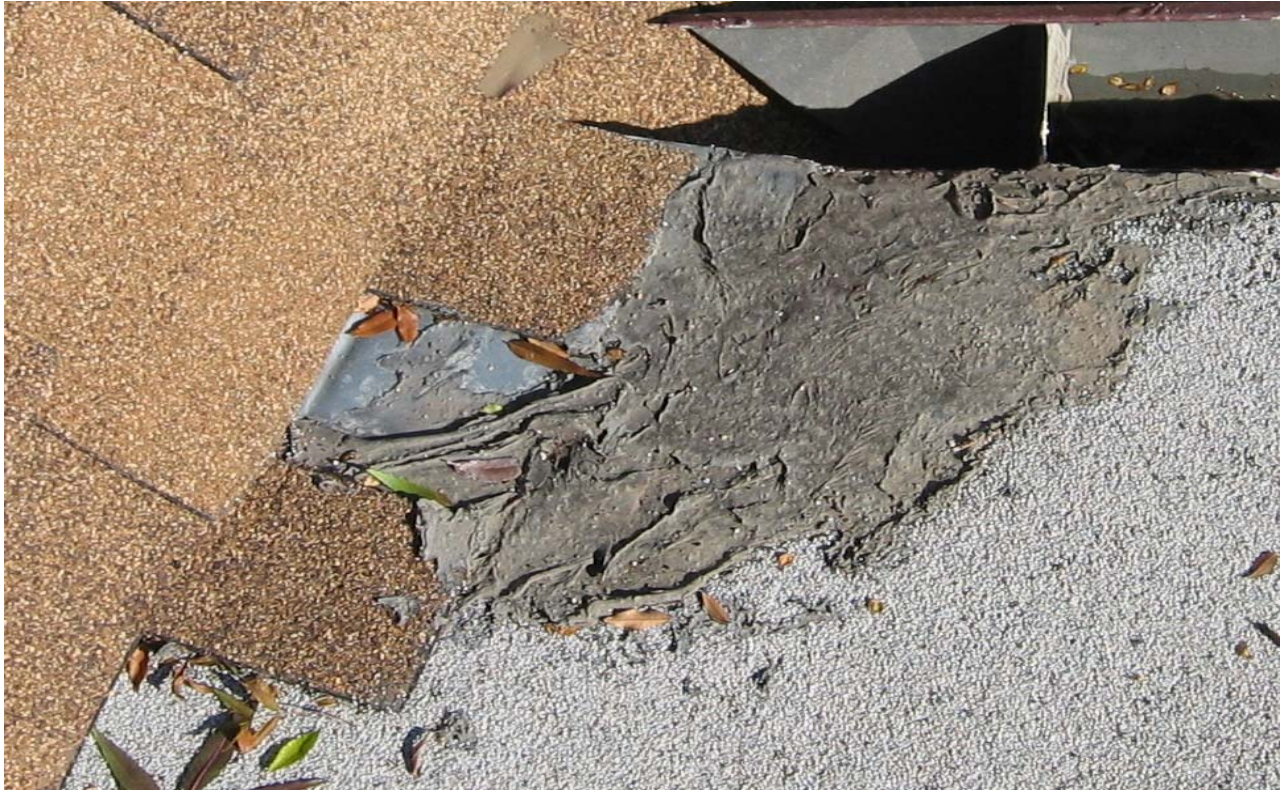
- **Repair:** Minor repairs to the roofing are recommended. Any damaged or missing roofing material should be replaced. All roof penetrations should be examined and sealed as necessary.
- **Repair:** Water staining was observed on the ceiling tiles in the nursery room of the church. The roof may be leaking in this area. Repair may be needed.
- **Monitor:** Several areas of the cap sheet roof have been previously repaired (tarred areas).

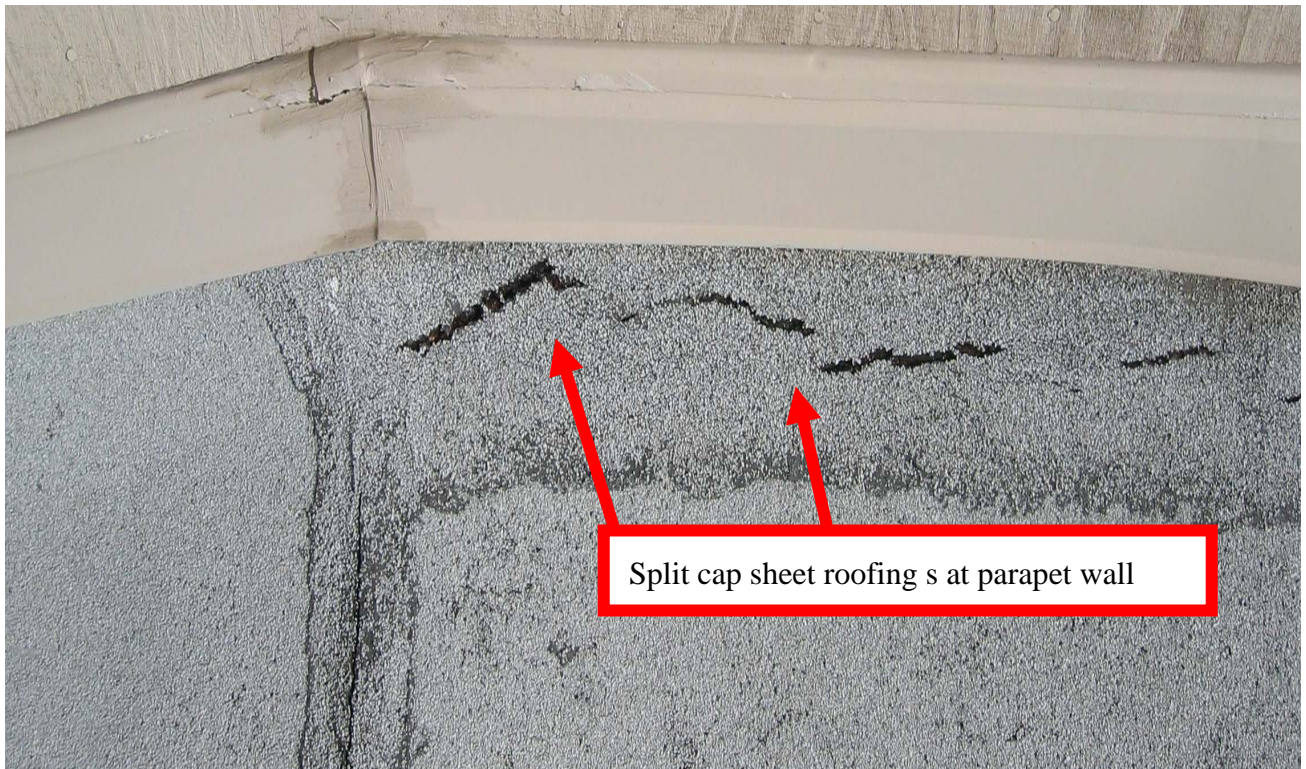
- **Repair:** The cap roof requires maintenance. Debris should be cleared from the roof. Voids in the gravel should be improved, and any damaged roofing should be repaired.

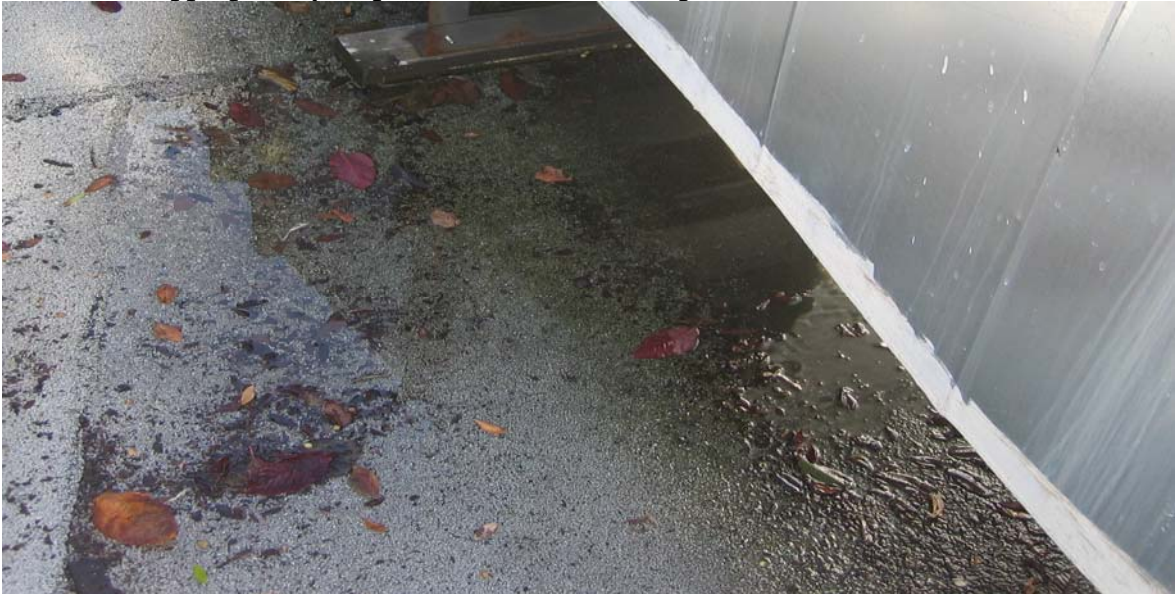
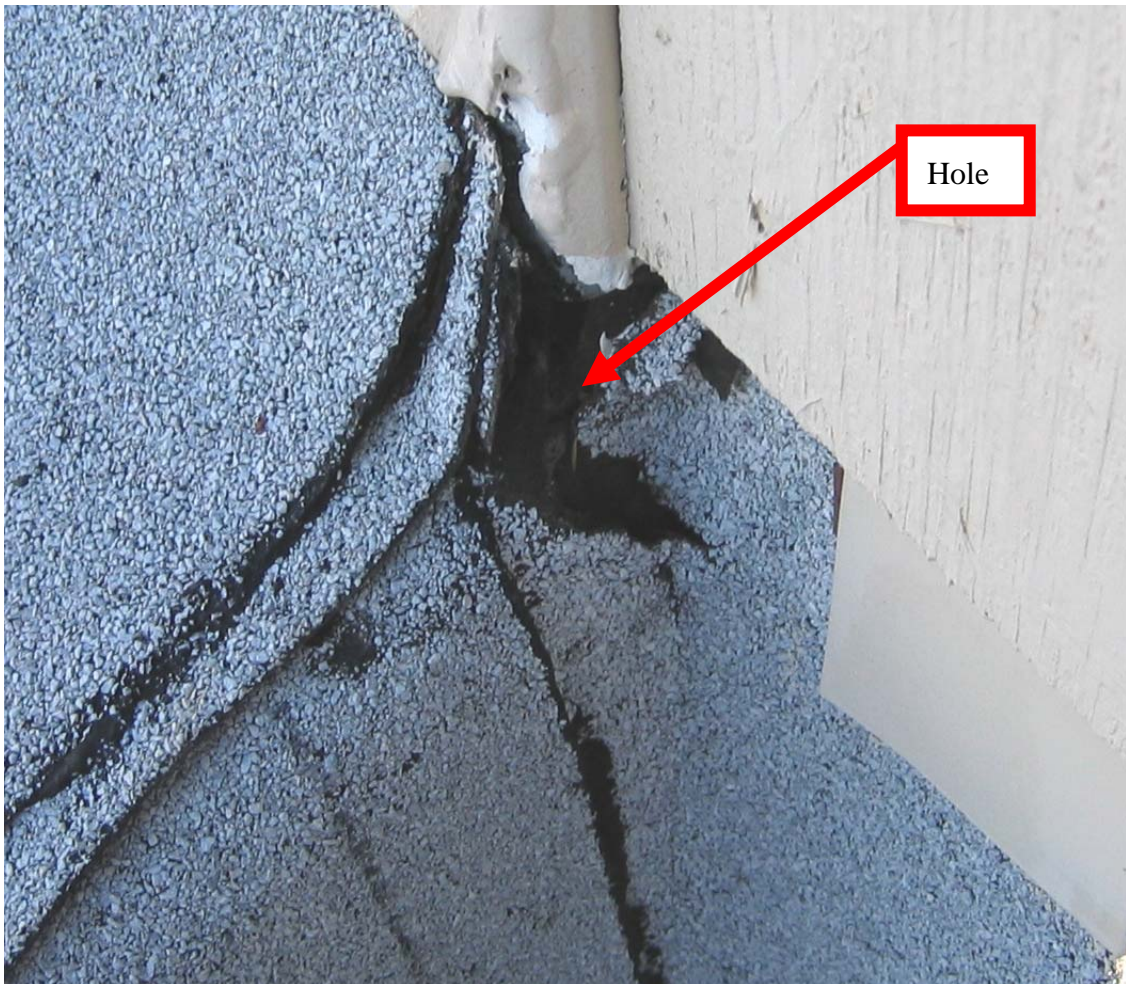
- **Monitor:** Water ponds on the membrane under the ductwork at several other locations. Ponding shortens the roof life and increases the potential for damage, if leaks occur. When re-roofing, the roof should be appropriately sloped or drains should be provided.

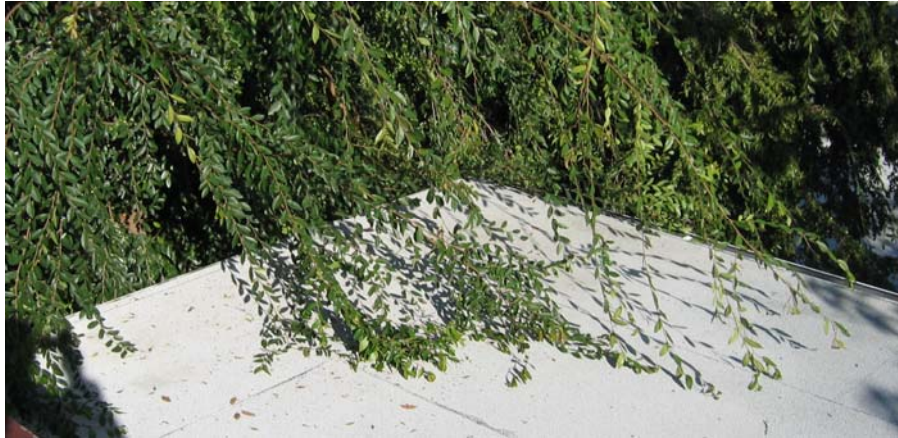
- **Repair:** The tree branches in close proximity to the roof should be trimmed.

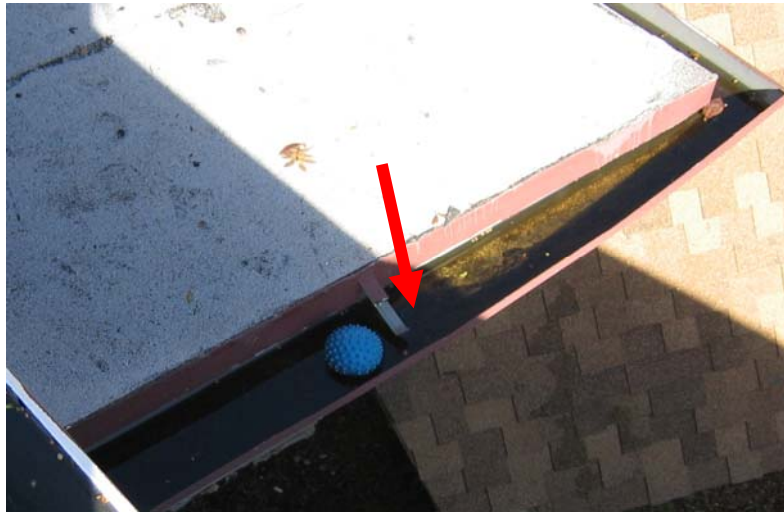
- **Repair:** Leaks in the gutters should be repaired.
- **Repair:** The loose gutters to the right of the main entry should be repaired (gutter hangers).

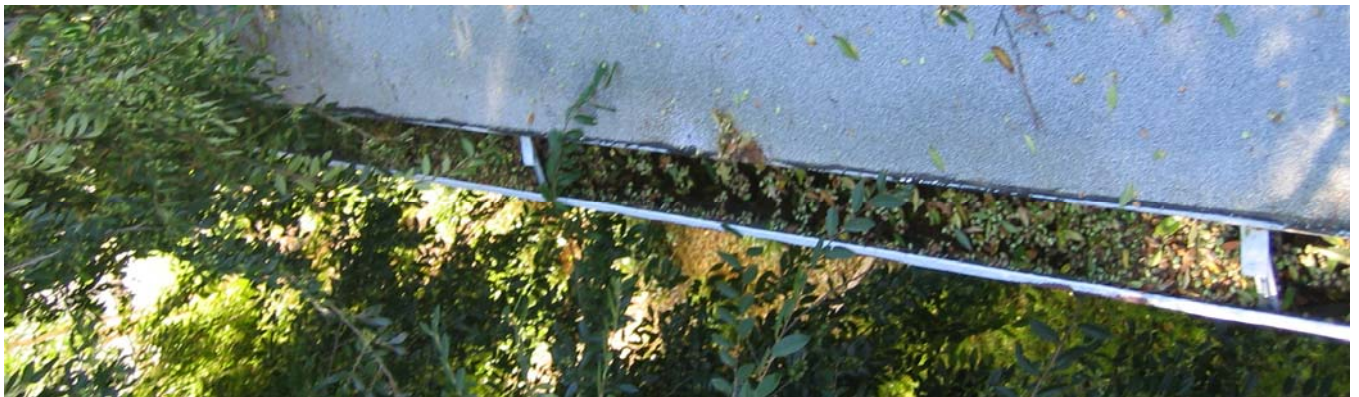
- **Repair:** The gutters require cleaning.

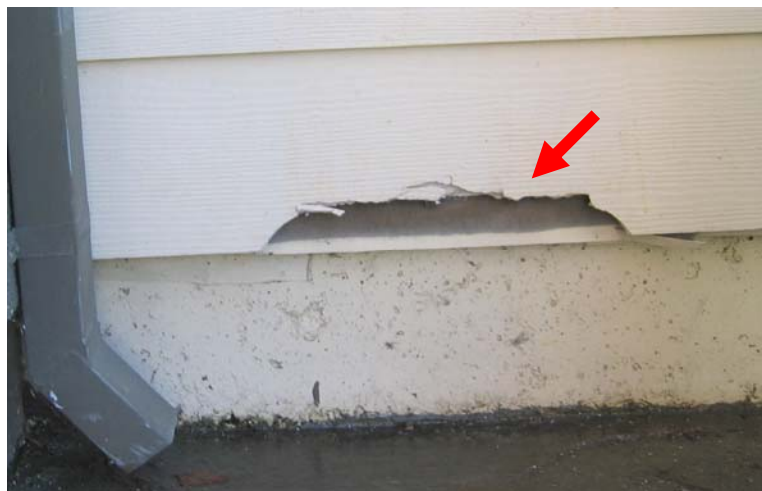
- **Repair:** The damaged concrete siding at the rear fence should be replaced.

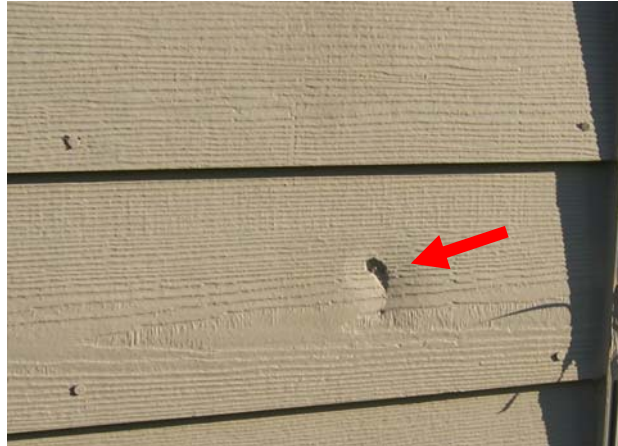
- **Repair:** The damaged siding at the rear wall should be repaired or replaced (hole).

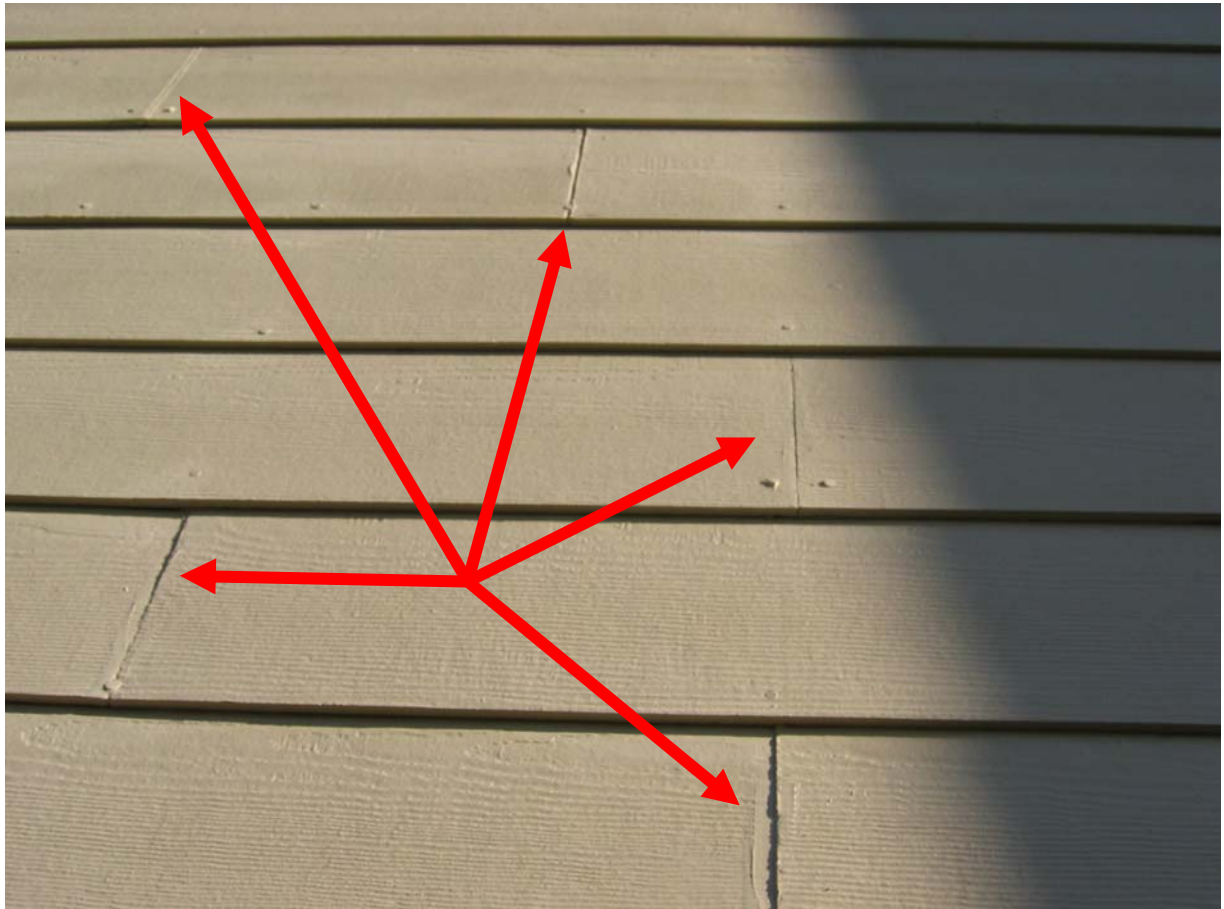
- **Repair:** Vegetation growing on or within six inches of exterior walls should be kept trimmed away from the roof and sides of the building.
- **Repair:** The concrete siding has been installed without the benefit of an expansion clip at the butt joint locations at the rear of the building. The siding expands and contracts with seasonal temperature and humidity changes. The large gap at the siding butt joint locations creates a vulnerable area for water intrusion. Maintaining a good silicone caulking seal at this vulnerable area is recommended.

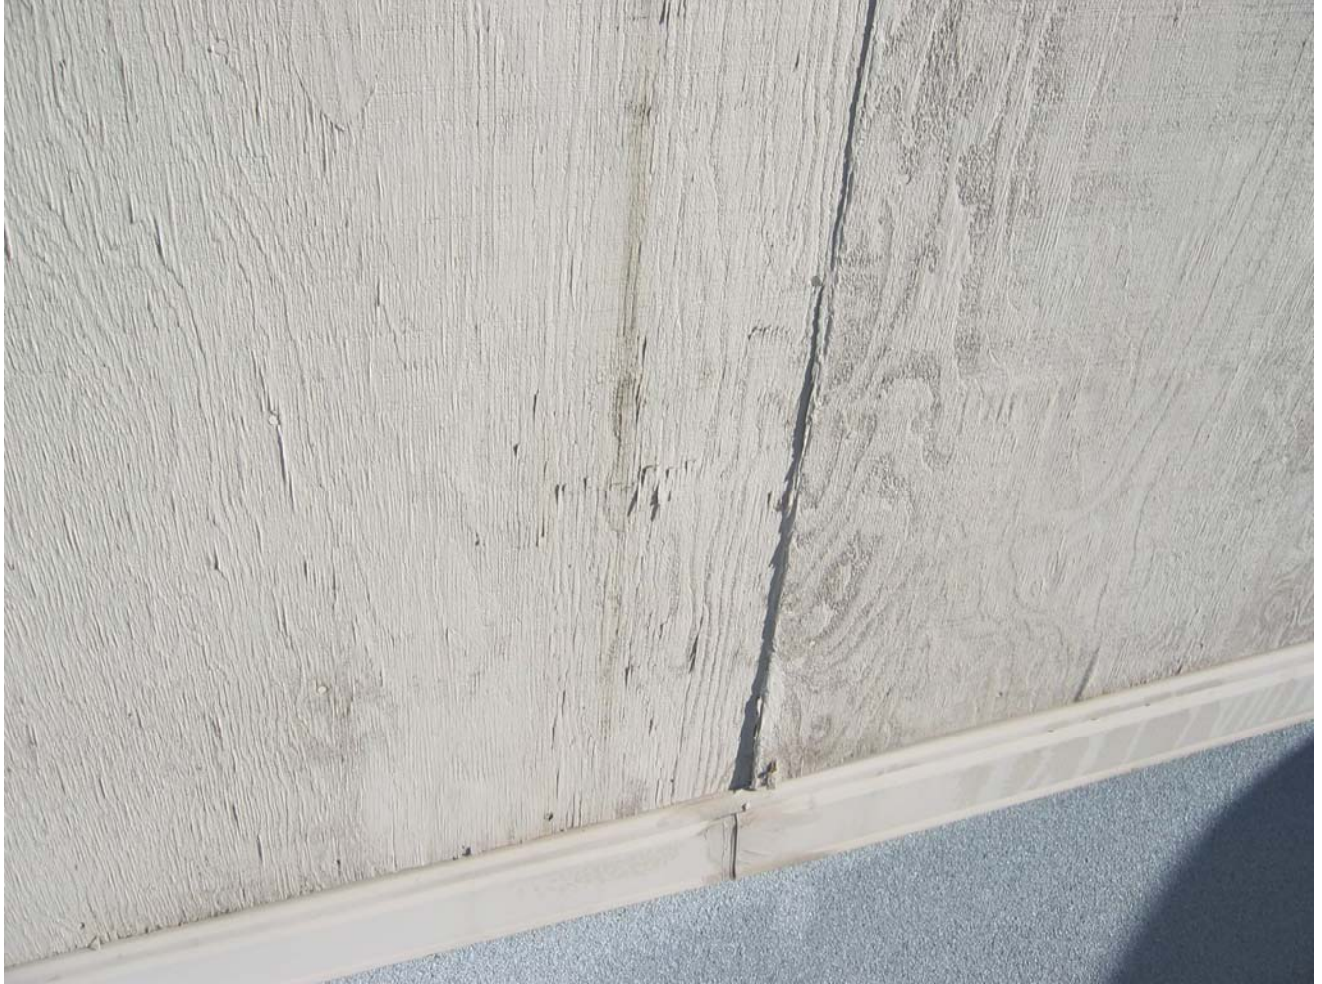
- **Repair:** The interior of the parapet walls are covered with plywood siding. Some of the plywood is delaminating. Repair or replacement of the damaged plywood siding is recommended.

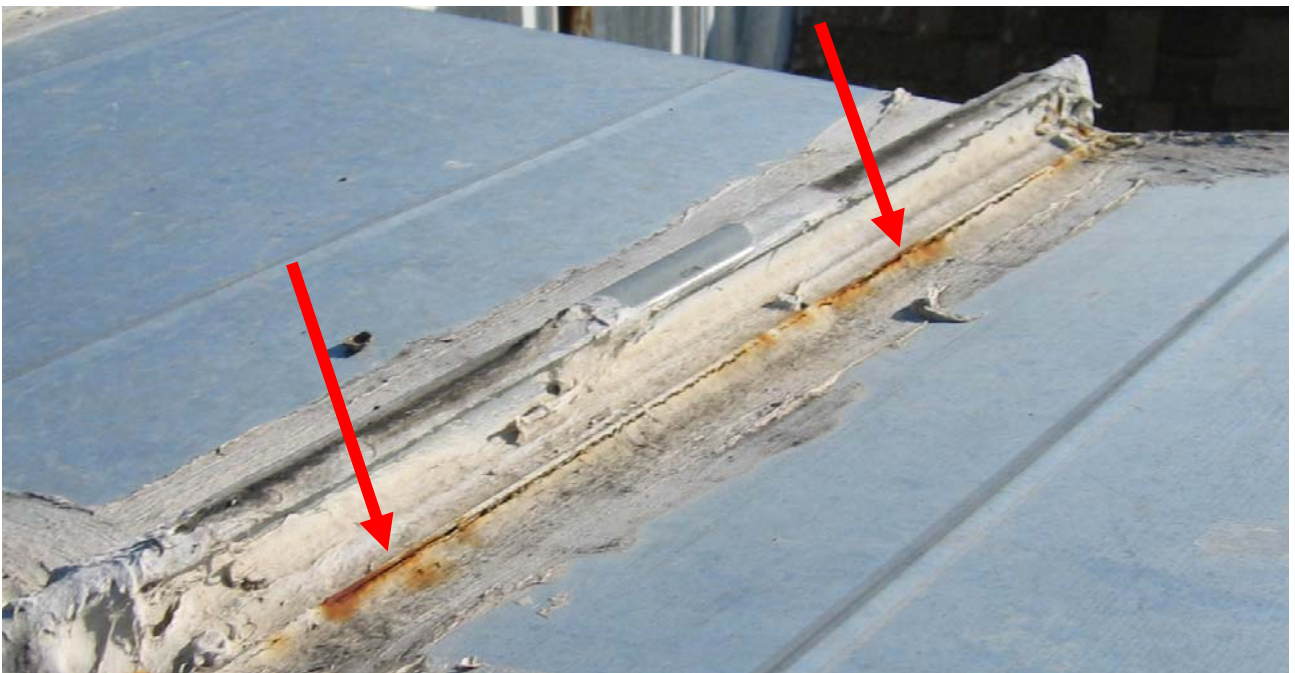
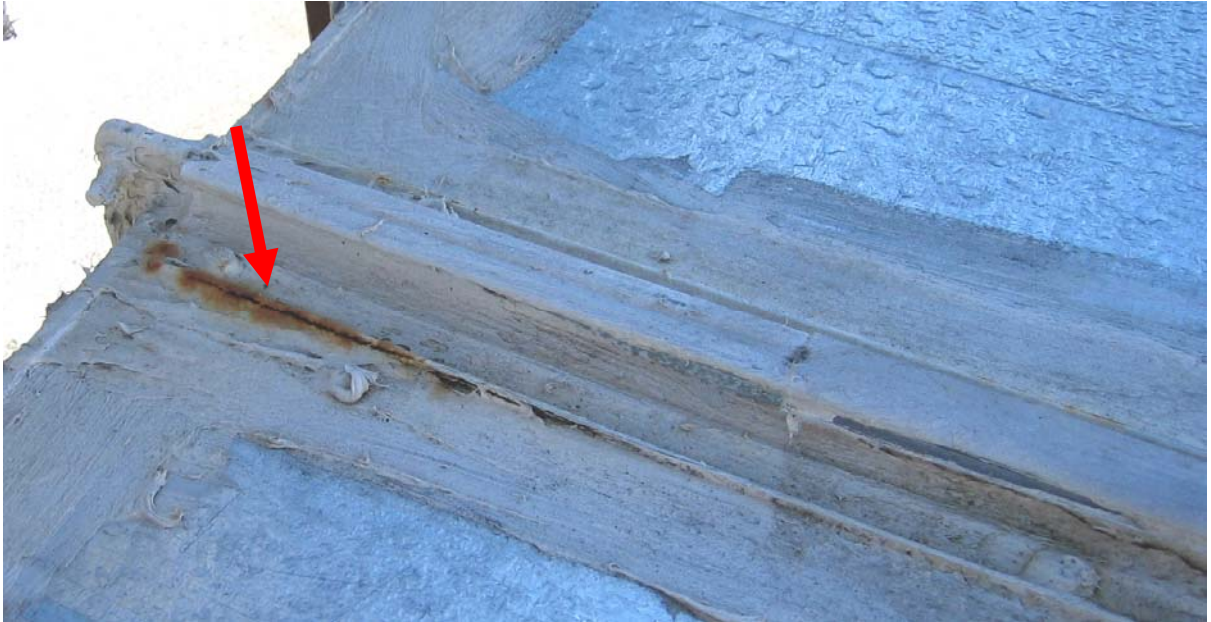
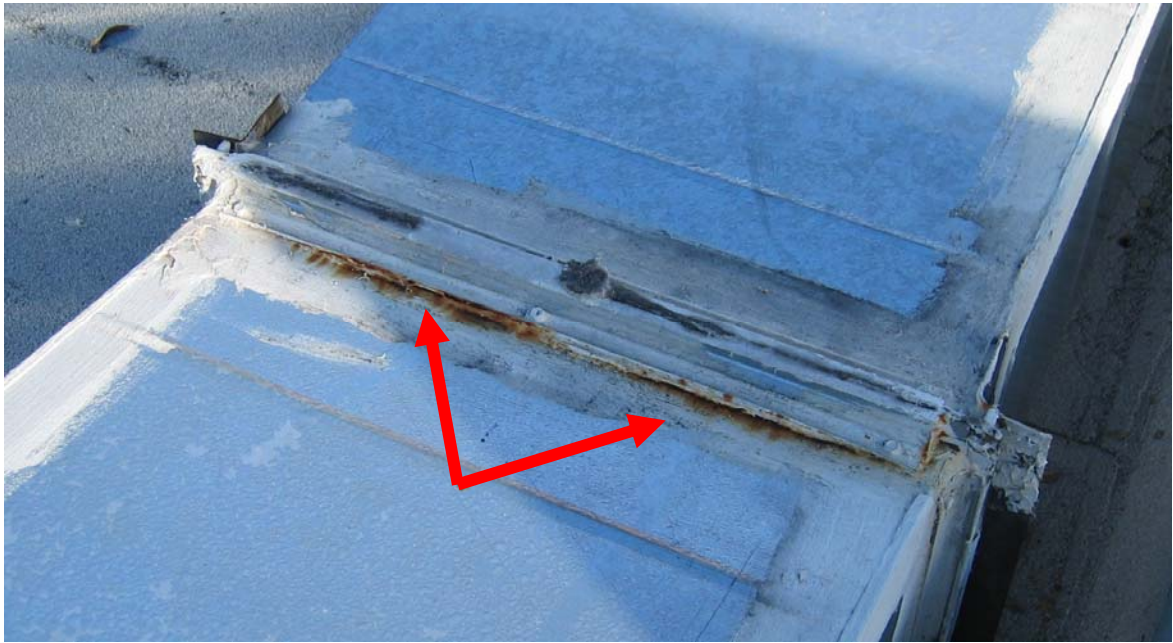
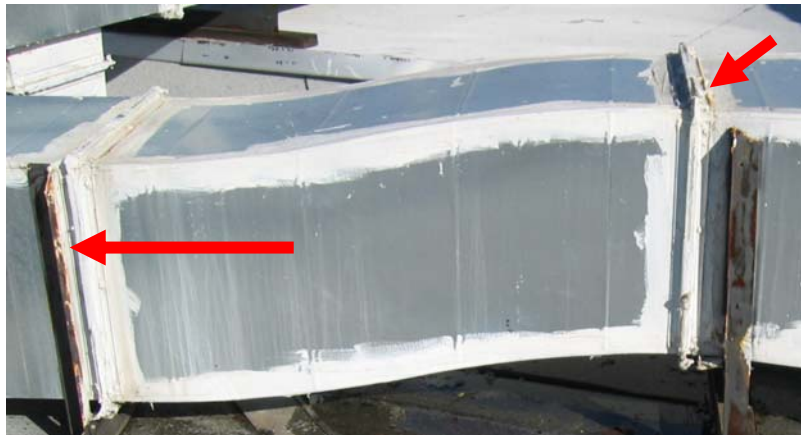
- **Repair:** The exposed metal rooftop ductwork shows evidence of corrosion at various joint locations. These areas should be resealed to help prevent further deterioration and/or leakage at these locations.

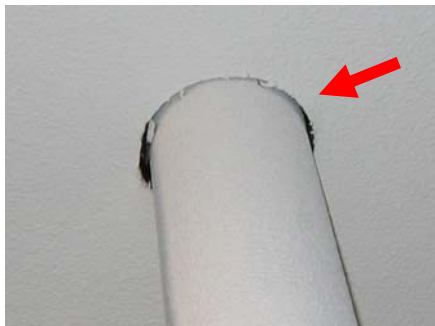
- **Safety Issue:** The “B-Vent” metal double-wall flue piping from the water heater is not sufficiently clear from combustible materials (sheetrock). A one-inch clearance from any combustible material is required. The clearance should be improved (fire safety).

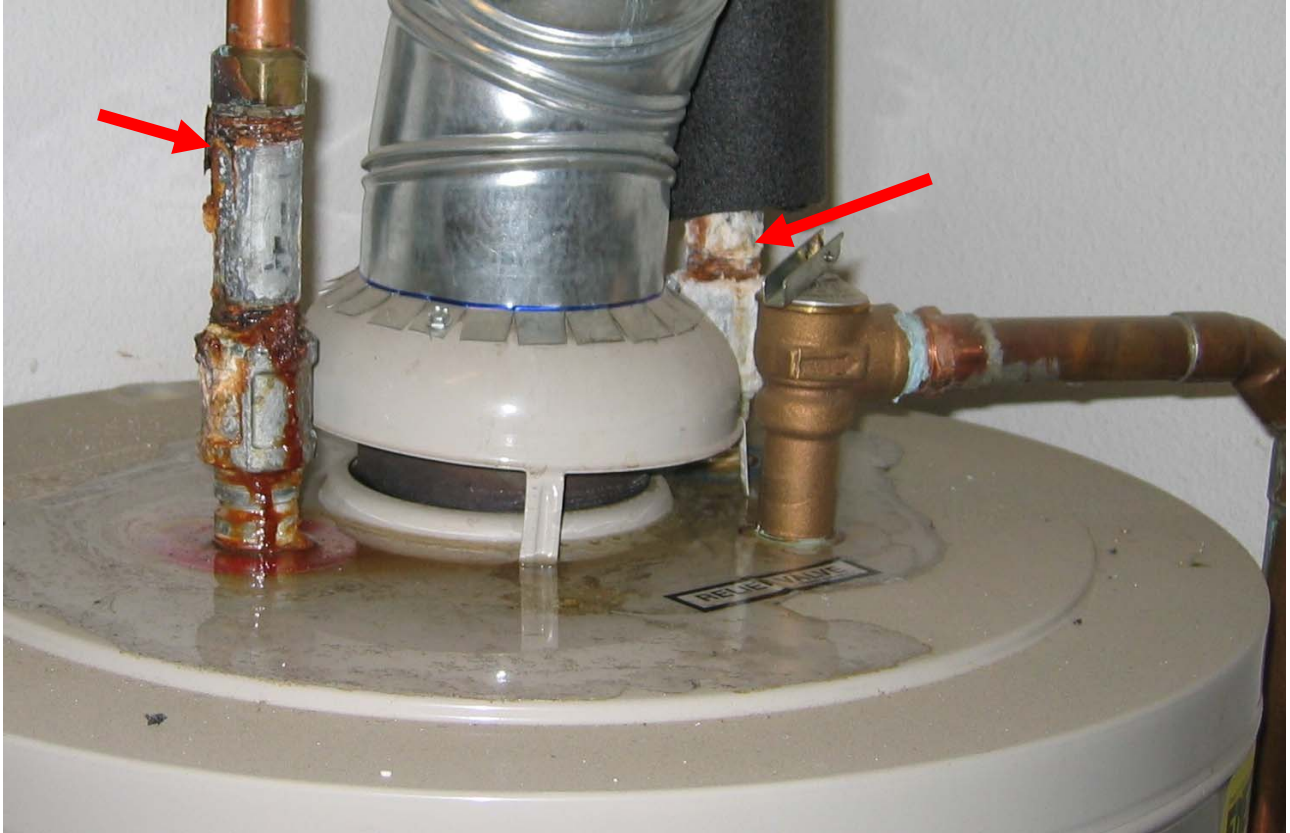
- **Repair:** The water piping is leaking at the water heater.

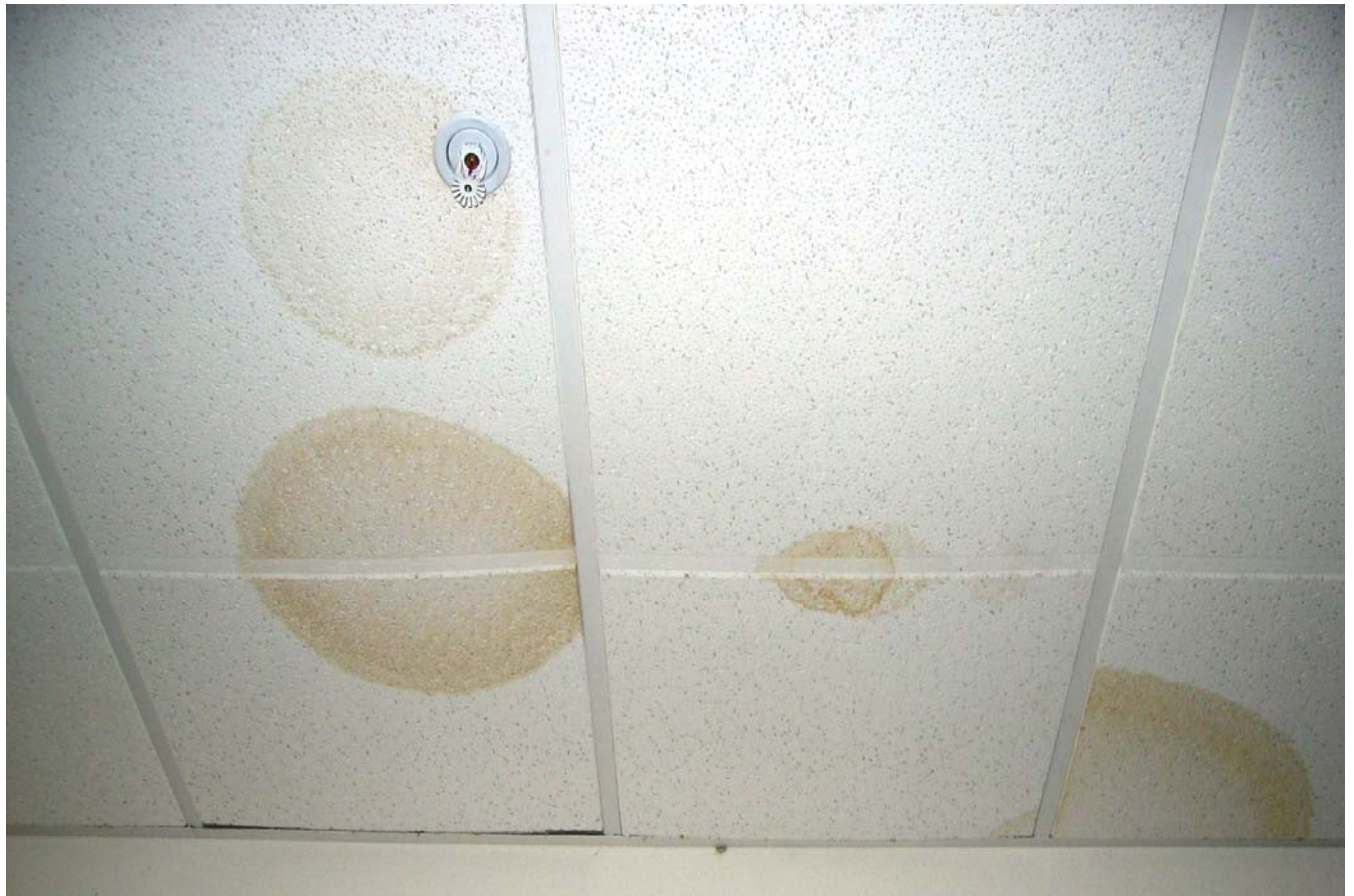
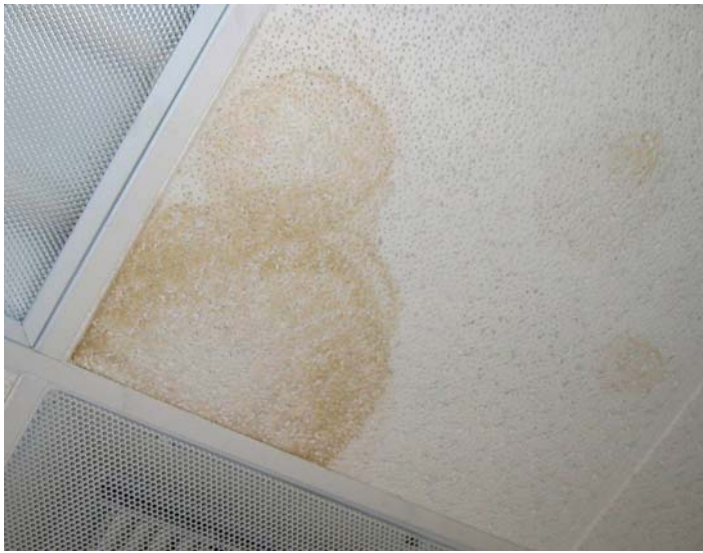
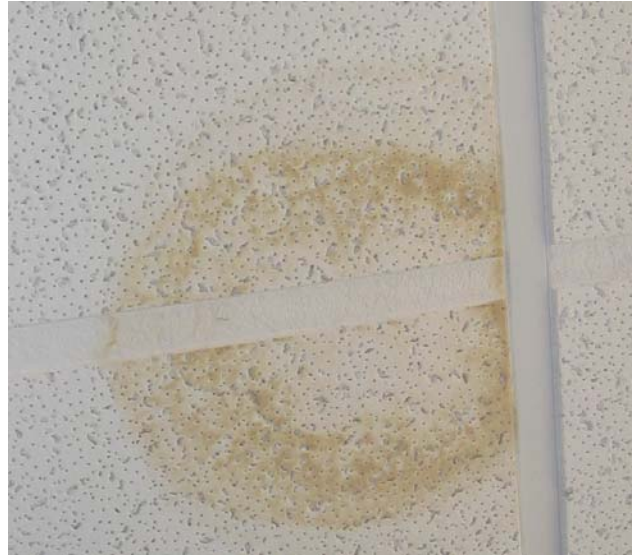
- **Monitor:** Evidence of roof leakage was observed (water staining in nursery). Please refer to the Roofing section of the report for recommendations.

- **Repair:** Water staining was observed on the ceiling tiles in the nursery room of the church. The damaged ceiling tiles should be replaced after roof repairs are performed.

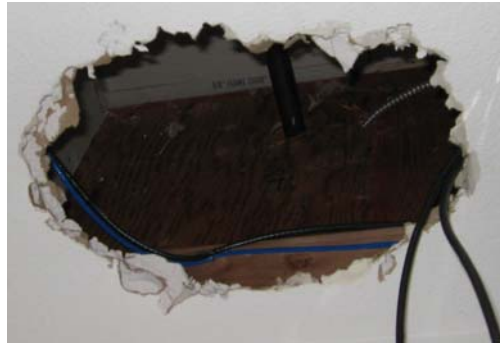
- **Monitor:** Minor flaws and cracks were noted in various locations of the interior. The cracking does not appear to be the result of a structural failure. Repairs will be necessary in some areas before painting.
- **Repair:** The opening in the sheetrock ceiling in the sound cabinet should be repaired.

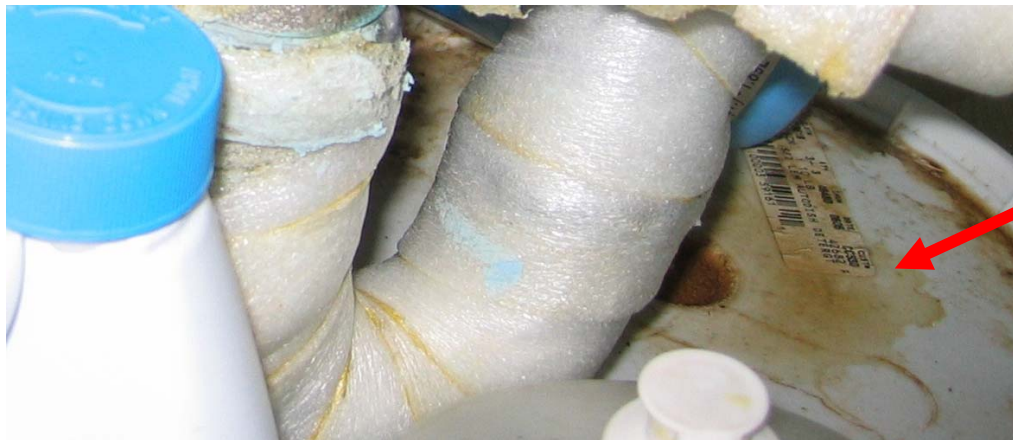
- **Improve:** The kitchen sink base shows evidence of water damage.

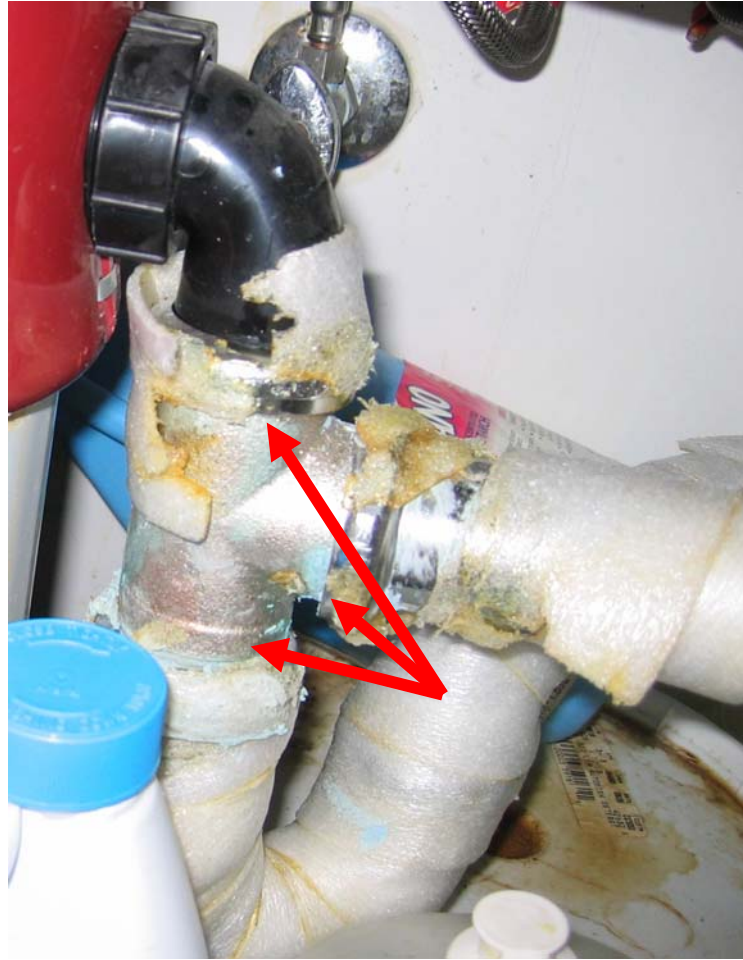
- **Repair:** The waste connection is leaking in the kitchen.

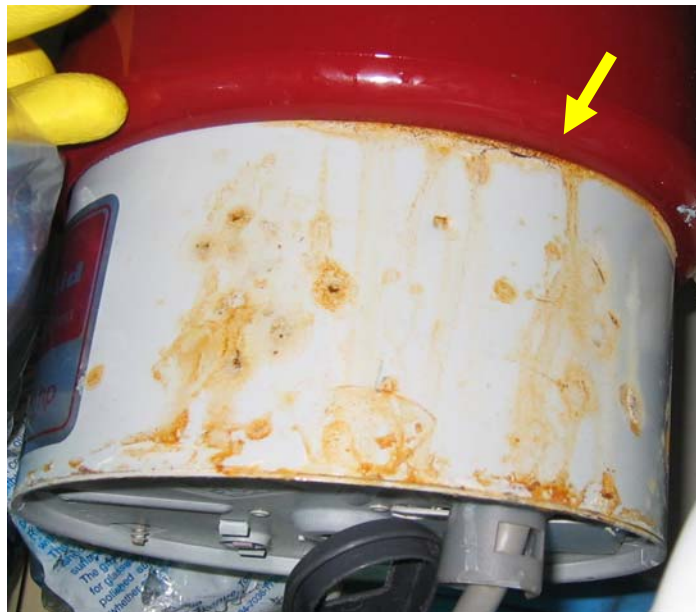
- **Repair:** The disposal shows evidence of leakage. Replacement is recommended.
